WATERSHIELD

CASE STUDY

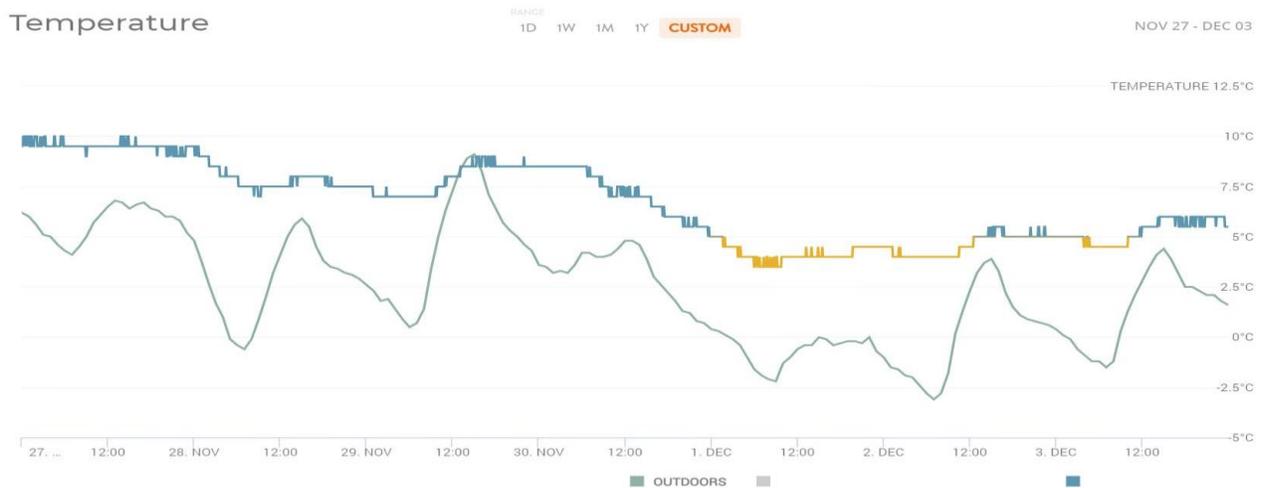
Temperature Alarms Begin December 1 as Room temp. (Blue) drops with Outdoor temp. (Green) ALERTS generated when Water Service Room temperature drops below 5°C (Yellow).

Through the month of November, although the outdoor temperature dropped below freezing overnight, the temperature of the water service room remained safely at not less than 7°C. On the night of November 30 and through the early part of December each time the outdoor temperature drop below 0°C the water service room temperature would fall below 5°C and an Alert would be generated.

WATERSHIELD alerted appropriate management staff regarding the freeze potential, as the room temperature at times dropped below 2°C. An investigation was conducted and a defective heater fan was discovered and repaired on December 17. The attached temperature trend log clearly shows the improved temperature control.
