CASE STUDY

Water loss in a medium sized residential apartment building in London Ontario. The water usage of the building is remotely monitored using an Alert Labs Flowie on the main municipal water meter. The Alert Labs algorithms compare water usage patterns and flow rates to identify potential leaks and excess water consumption.

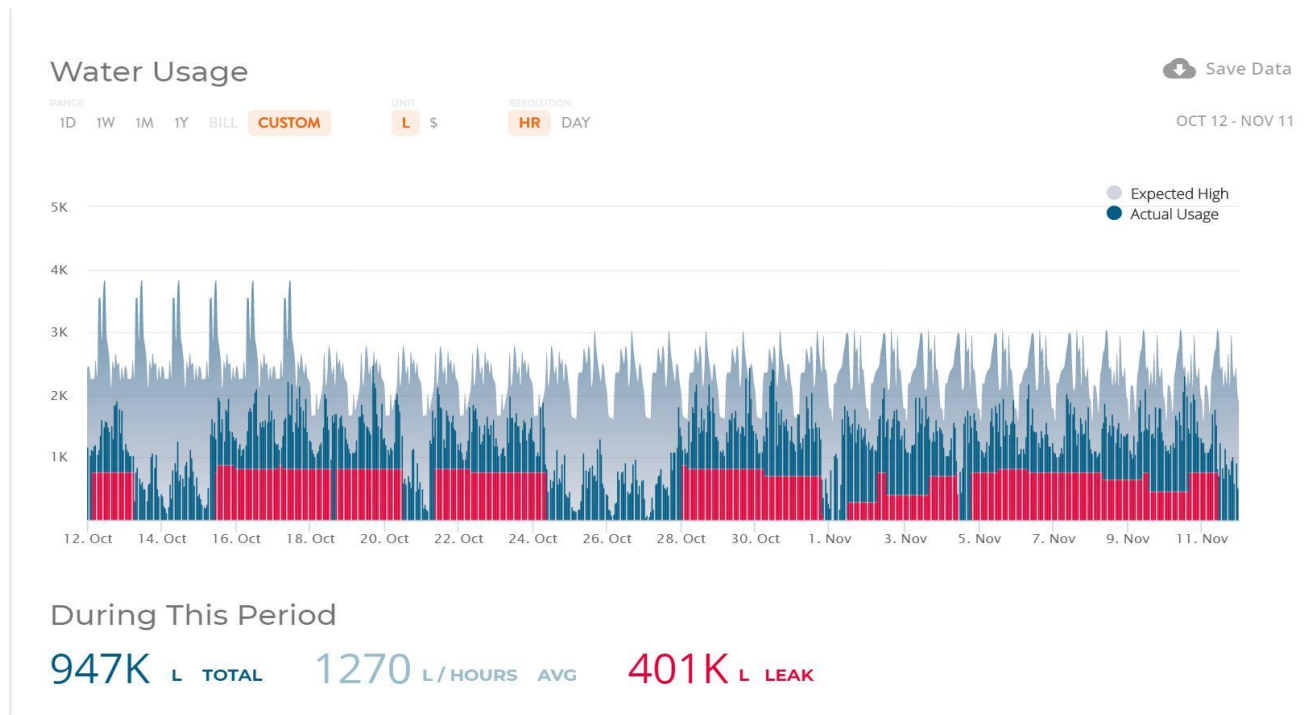
From mid-October to mid-November, the Alert Labs Flowie recorded an unusual pattern of water use at Granite House. Although there were periods with a normal water consumption during the month, there were also extended periods when the water usage was approximately double the normal usage rate. WATERSHIELD was receiving intermittent alarms regarding the water use at this property.

Water Usage Profile from October 12 – November 11: Average daily usage 30.5 m3/day.

We analyzed the usage profile and scheduled an inspection to determine the cause(s) of the excess water use or loss. The inspection revealed a number of minor plumbing fixture leaks, (shower heads and taps), that were resolved and the building now shows a normal and consistent pattern of water usage.

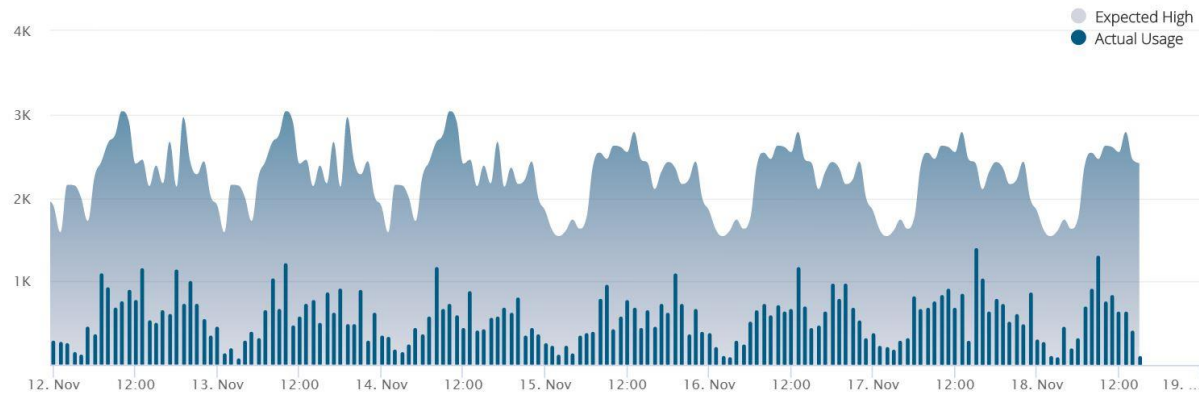
Water Usage Profile from November 12 - 18: Average daily usage 14.3 m3/day.

92.8K L TOTAL 552 L/HOURS AVG

Since the inspections into water usage/loss have been conducted, the water consumption at this property has been reduced by approximately 50%. The resolution of this excess water loss will result in the saving of approximately \$2,200.00 per month.
